Home Seller Drainage Survey Plus Report Prepared For:

Drainage Survey Plus Home Seller

Section Inspection - 20/01/2025 - MH1X

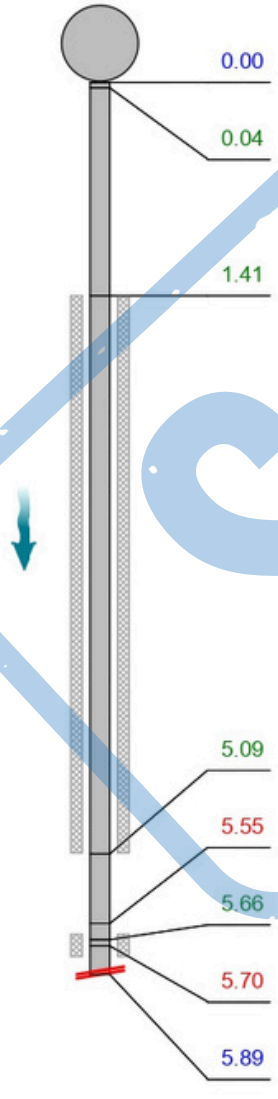
Scale: 1:51	Position [m]	Code	Observation	MPEG	Photo	Grade
	0.00	ST	Start of survey	00:00:00	MH1X_cb29c6ac-d7e1-4b53-bf7	
	0.04	LR	Line of sewer deviates right	00:00:01	MH1X_b8dcafda-5f8a-4f10-9be	
	1.41	S01 DEG	Debris, grease from 11 o'clock to 1 o'clock, 10% cross-sectional area loss, start	00:00:15	MH1X_56058701-330a-4e09-9	3
	5.09	C01 DEG	Debris, grease from 11 o'clock to 1 o'clock, 5% cross-sectional area loss, change	00:00:28	MH1X_c3427ae5-0be0-45a8-a0	
	5.55	D	Deformed sewer, 15% of original diameter/height: From 6 to 12 O'clock	00:00:30	MH1X_7896ce19-51e1-4bd7-9f	3
	5.66	WL	Water level, 10% of sewer height	00:00:32		
	5.70	S02 D	Deformed sewer, 15% of original diameter/height, start: 12 O'clock	00:00:32	MH1X_72b9f780-b977-4ce6-a	3
	5.89	SA	Survey abandoned: Unable to push camera	00:00:51	MH1X_10093812-9238-453a-9

Construction Features					Miscellaneous Features				
Structural Defects					Service & Operational Observations				
STR No. Def	STR Peak	STR Mean	STR Total	STR Grade	SER No. Def	SER Peak	SER Mean	SER Total	SER Grade
2	40.0	13.6	80.0	3.0	1	0.0	0.3	2.0	1.0

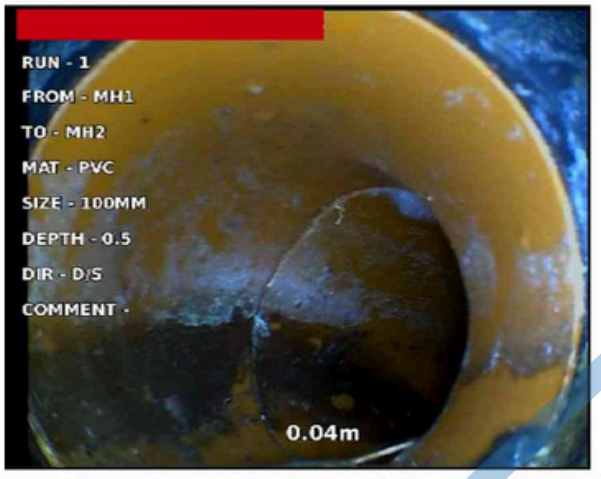
MH1X_cb29c6ac-d7e1-4b53-bf72-bab27975cc62_20250120_133304_317.jpg, 00:00:00, 0.00 m
Start of survey

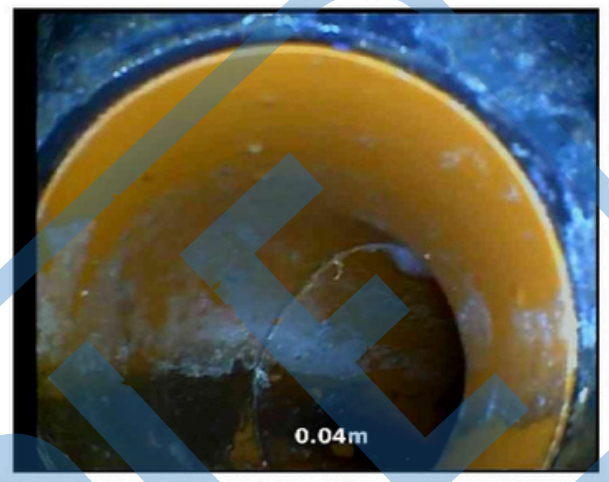
MH1X_b8dcafda-5f8a-4f10-9bec-bf7dca9b7672_20250120_133350_587.jpg, 00:00:01, 0.04 m
Line of sewer deviates right

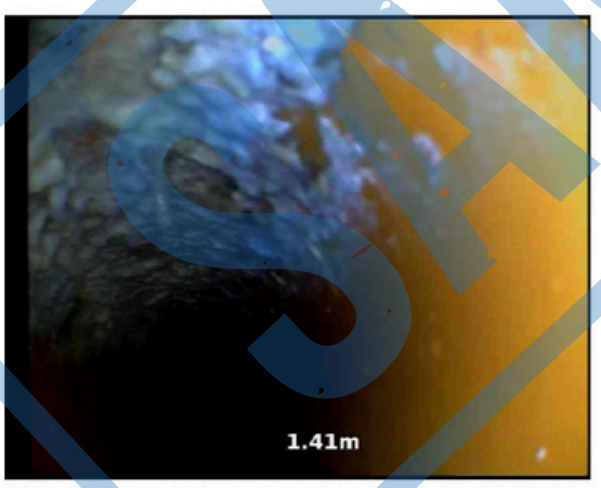
MH1X_56058701-330a-4e09-9a0f-4ca356bca2fe_20250120_133433_013.jpg, 00:00:15, 1.41 m
Debris, grease from 11 o'clock to 1 o'clock, 10% cross-sectional area loss, start

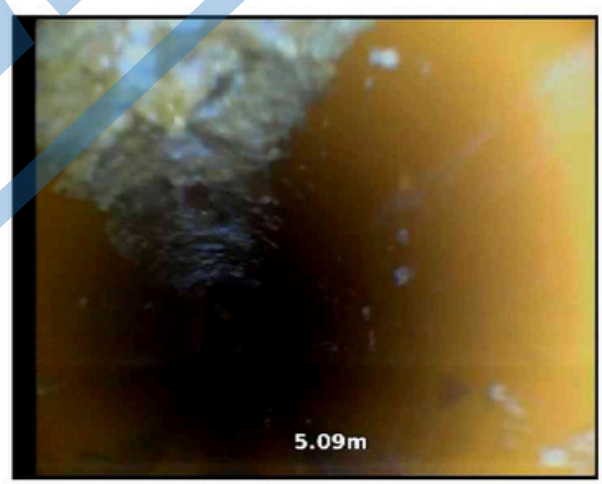
MH1X_c3427ae5-0be0-45a8-a0ab-e60ed2c62379_20250120_133507_718.jpg, 00:00:28, 5.09 m
Debris, grease from 11 o'clock to 1 o'clock, 5% cross-sectional area loss, change

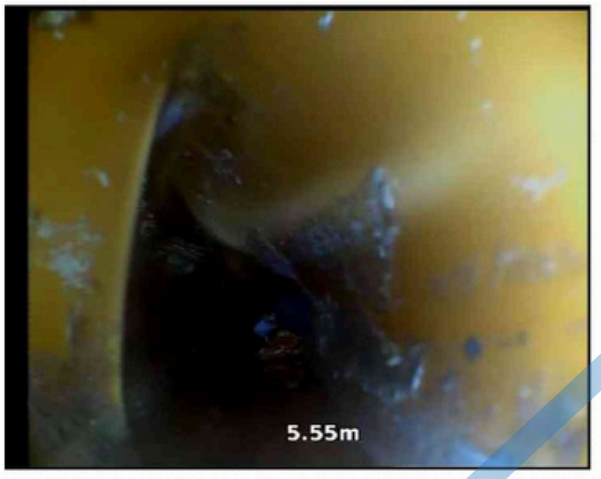
MH1X_7896ce19-51e1-4bd7-9fb7-358c01b626eb_20250120_133553_482.jpg, 00:00:30, 5.55 m
Deformed sewer, 15% of original diameter/height, From 6 to 12 O'clock

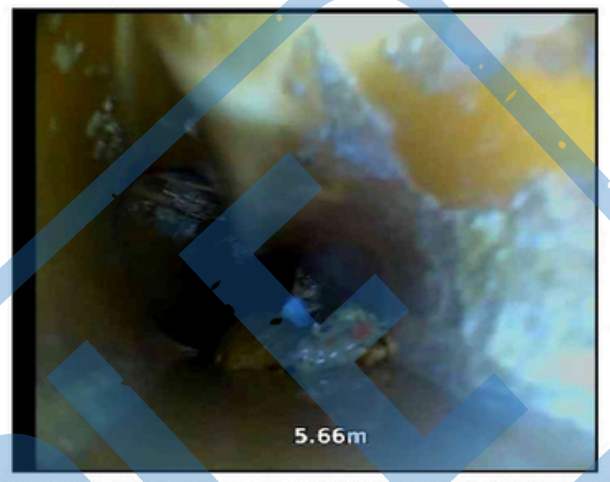
MH1X_72b9f780-b977-4ce6-aac6-30e32f2909a7_20250120_133632_377.jpg, 00:00:32, 5.70 m
Deformed sewer, 15% of original diameter/height, start, 12 O'clock

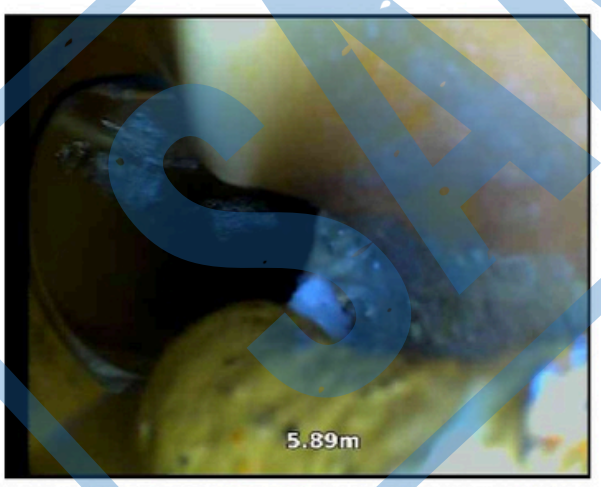
MH1X_10093812-9238-453a-99a7-651d7dc8d95c_20250120_133800_238.jpg, 00:00:51, 5.89 m
Survey abandoned, Unable to push camera

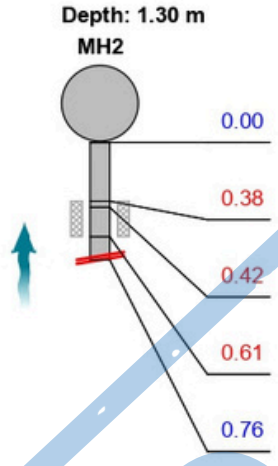
Position [m]	Code		Observation	MPEG	Photo	Grade
0.00		ST	Start of survey	00:00:00	MH1X_b53e8da0-8edf-416d-ad	
0.38	S01	D	Deformed sewer, 10% of original diameter/height, start: at 10 O'clock	00:00:08	MH1X_2aef634b-99ce-4329-8	2
0.42	C01	D	Deformed sewer, 20% of original diameter/height, change: at 10 O'clock	00:00:08	MH1X_31cd0bca-9743-4b55-bd	
0.61	C01	D	Deformed sewer, 20% of original diameter/height, change: From 8 to 12 O'clock	00:00:09	MH1X_0ead1eea-6abd-4097-b	
0.76		SA	Survey abandoned: Unable to push camera past	00:00:11	MH1X_a2c45cb7-d2ab-4a43-b4

Construction Features					Miscellaneous Features				
Structural Defects					Service & Operational Observations				
STR No. Def	STR Peak	STR Mean	STR Total	STR Grade	SER No. Def	SER Peak	SER Mean	SER Total	SER Grade
1	0.0	26.3	20.0	2.0	0	0.0	0.0	0.0	1.0

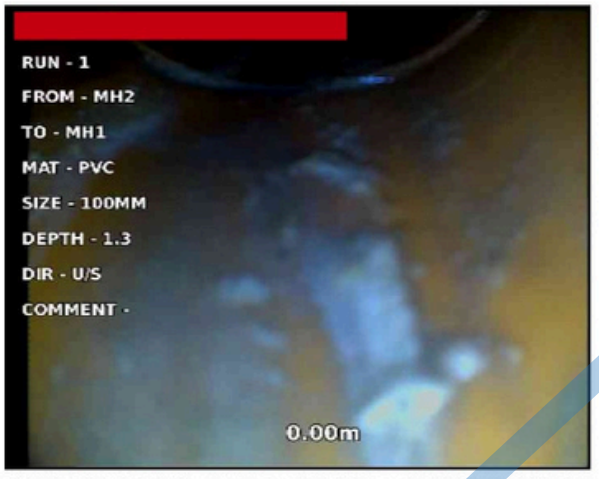
MH1X_b53e8da0-8edf-416d-adb7-521aec5a8525_20250120_133913_873.jpg, 00:00:00, 0.00 m
Start of survey

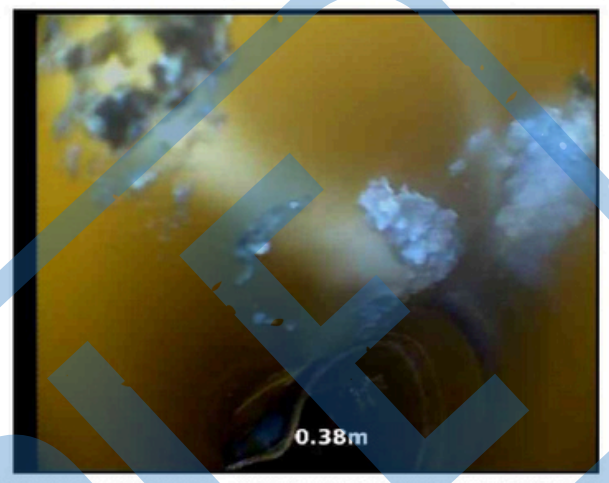
MH1X_2aef634b-99ce-4329-8ae6-b0b68861c6e4_20250120_134027_186.jpg, 00:00:08, 0.38 m
Deformed sewer, 10% of original diameter/height, start, at 10 O'clock

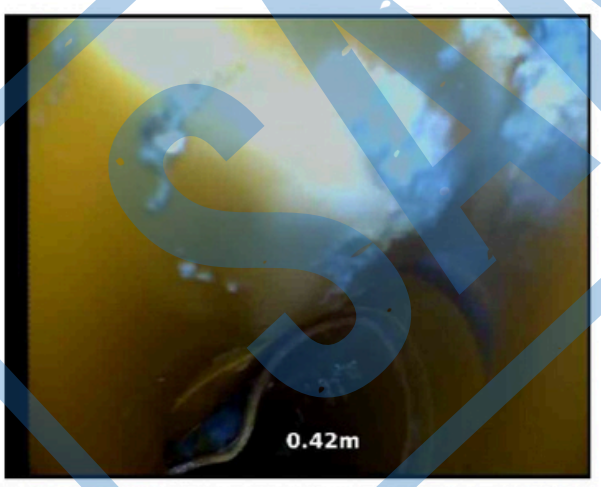
MH1X_31cd0bca-9743-4b55-bd9b-c455b6255c9d_20250120_134102_101.jpg, 00:00:08, 0.42 m
Deformed sewer, 20% of original diameter/height, change, at 10 O'clock

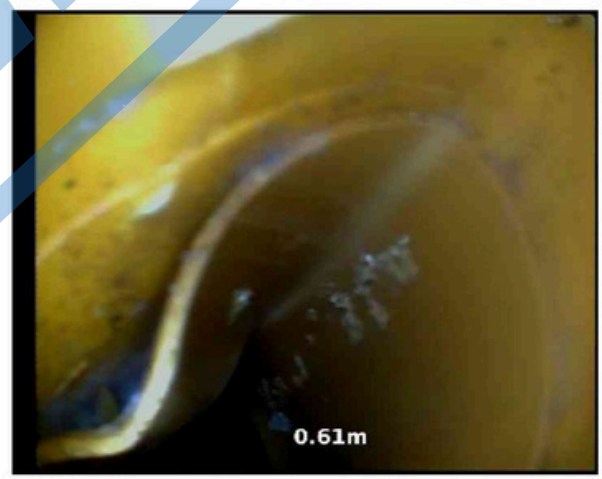
MH1X_0ead1eea-6abd-4097-b27f-b7b020615ea3_20250120_134214_214.jpg, 00:00:09, 0.61 m
Deformed sewer, 20% of original diameter/height, change, From 8 to 12 O'clock

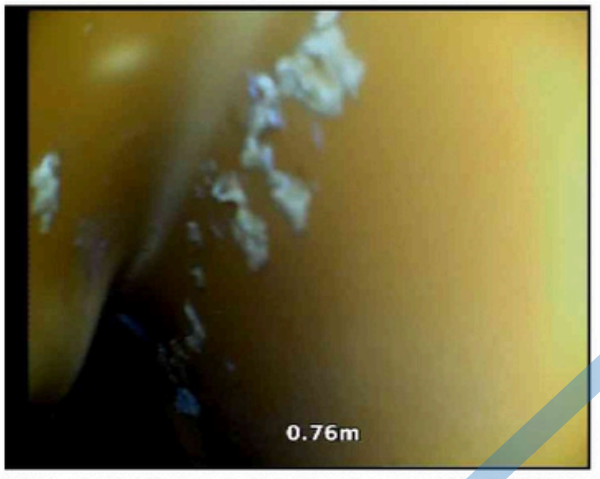
MH1X_a2c45cb7-d2ab-4a43-b42d-48ccef41a087_20250120_134255_553.jpg, 00:00:11, 0.76 m
Survey abandoned, Unable to push camera past
