Section Inspection - 20/01/2025 - MH1X

Section Pictures - 20/01/2025 - MH1X

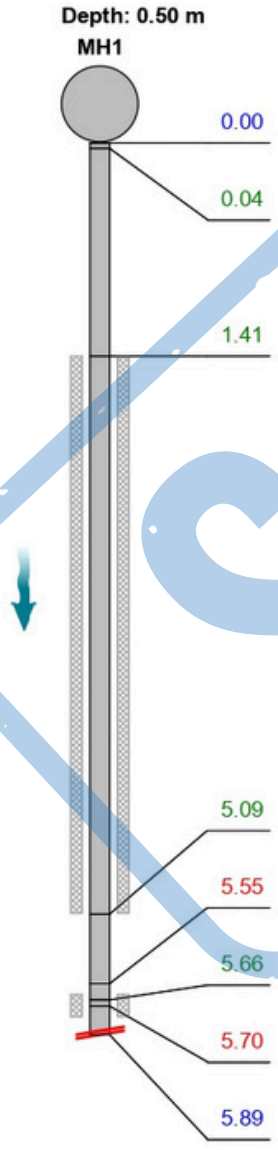
Position [m]	Code		Observation	MPEG	Photo	Grade
0.00		ST	Start of survey	00:00:00	MH1X_cb29c6ac-d7e1-4b53-bf7	
0.04		LR	Line of sewer deviates right	00:00:01	MH1X_b8dcafda-5f8a-4f10-9be	
1.41	S01	DEG	Debris, grease from 11 o'clock to 1 o'clock, 10% cross-sectional area loss, start	00:00:15	MH1X_56058701-330a-4e09-9	3
5.09	C01	DEG	Debris, grease from 11 o'clock to 1 o'clock, 5% cross-sectional area loss, change	00:00:28	MH1X_c3427ae5-0be0-45a8-a0	
5.55		D	Deformed sewer, 15% of original diameter/height: From 6 to 12 O'clock	00:00:30	MH1X_7896ce19-51e1-4bd7-9f	3
5.66		WL	Water level, 10% of sewer height	00:00:32		
5.70	S02	D	Deformed sewer, 15% of original diameter/height, start: 12 O'clock	00:00:32	MH1X_72b9f780-b977-4ce6-a	3
5.89		SA	Survey abandoned: Unable to push camera	00:00:51	MH1X_10093812-9238-453a-9

Construction Features					Miscellaneous Features				
Structural Defects					Service & Operational Observations				
STR No. Def	**STR Peak**	**STR Mean**	**STR Total**	**STR Grade**	**SER No. Def**	**SER Peak**	**SER Mean**	**SER Total**	**SER Grade**
2	40.0	13.6	80.0	3.0	1	0.0	0.3	2.0	1.0

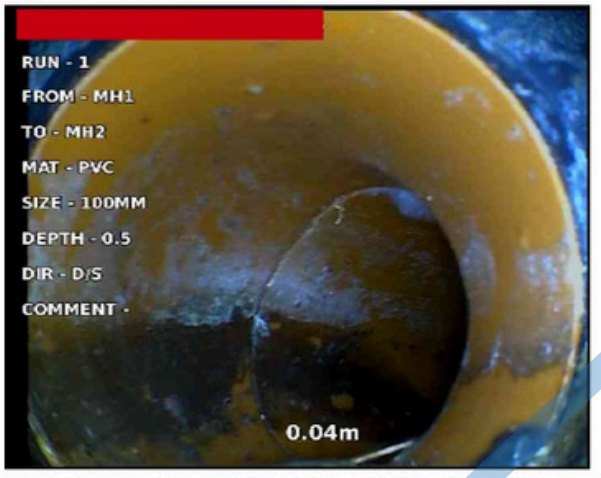
MH1X_cb29c6ac-d7e1-4b53-bf72-bab27975cc62_20250120_133304_317.jpg, 00:00:00, 0.00 m
Start of survey

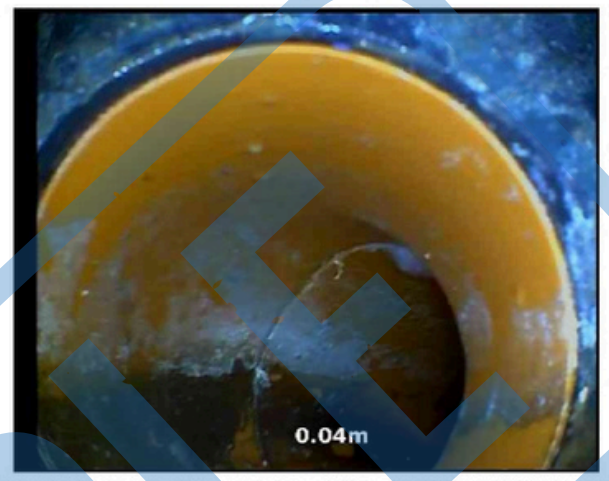
MH1X_b8dcafda-5f8a-4f10-9bec-bf7dca9b7672_20250120_133350_587.jpg, 00:00:01, 0.04 m
Line of sewer deviates right

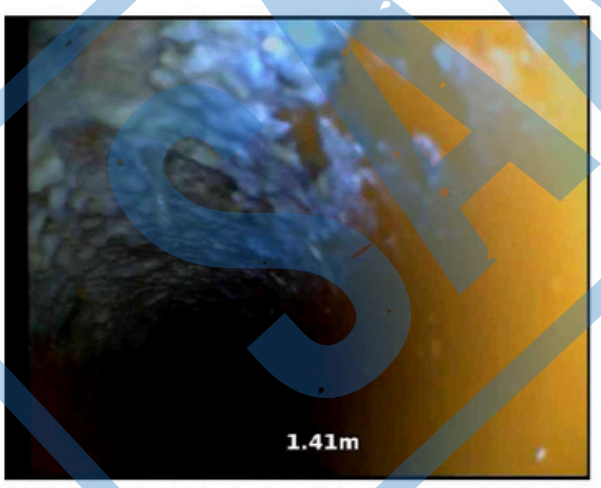
MH1X_56058701-330a-4e09-9a0f-4ca356bca2fe_20250120_133433_013.jpg, 00:00:15, 1.41 m
Debris, grease from 11 o'clock to 1 o'clock, 10% cross-sectional area loss, start

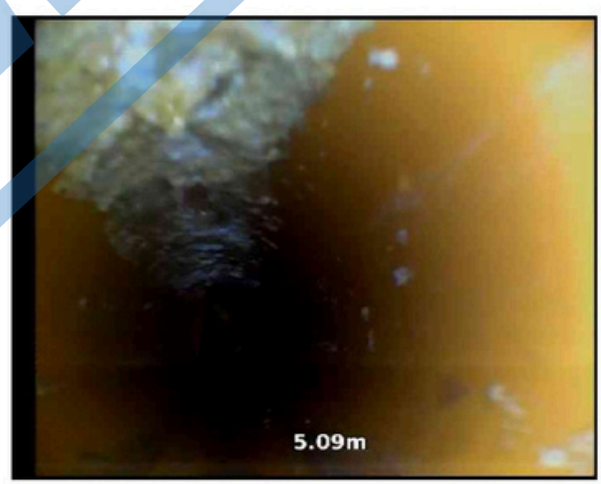
MH1X_c3427ae5-0be0-45a8-a0ab-e60ed2c62379_20250120_133507_718.jpg, 00:00:28, 5.09 m
Debris, grease from 11 o'clock to 1 o'clock, 5% cross-sectional area loss, change

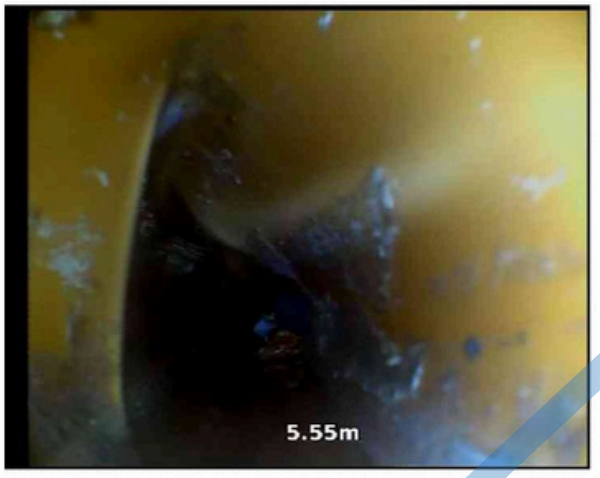
MH1X_7896ce19-51e1-4bd7-9fb7-358c01b626eb_20250120_133553_482.jpg, 00:00:30, 5.55 m
Deformed sewer, 15% of original diameter/height, From 6 to 12 O'clock

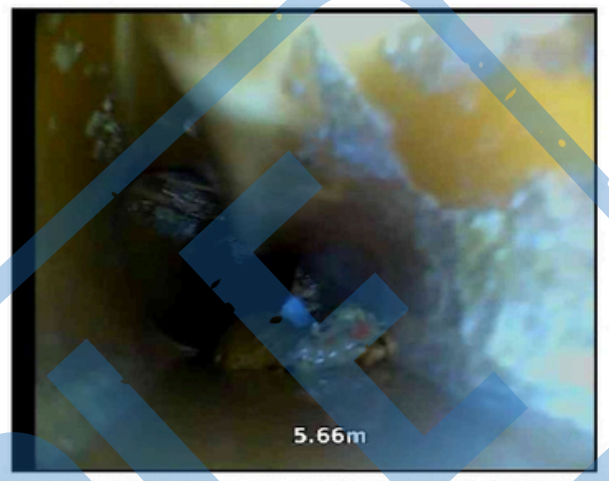
MH1X_72b9f780-b977-4ce6-aac6-30e32f2909a7_20250120_133632_377.jpg, 00:00:32, 5.70 m
Deformed sewer, 15% of original diameter/height, start, 12 O'clock

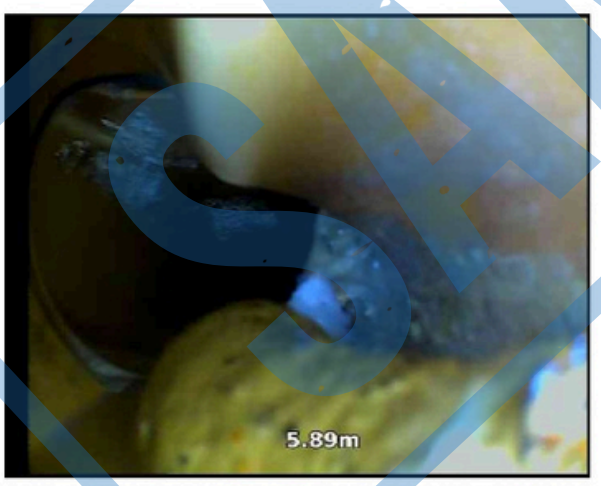
MH1X_10093812-9238-453a-99a7-651d7dc8d95c_20250120_133800_238.jpg, 00:00:51, 5.89 m
Survey abandoned, Unable to push camera

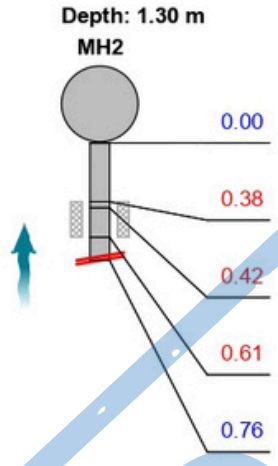
Position [m]	Code		Observation	MPEG	Photo	Grade
0.00		ST	Start of survey	00:00:00	MH1X_b53e8da0-8edf-416d-ad	
0.38	S01	D	Deformed sewer, 10% of original diameter/height, start: at 10 O'clock	00:00:08	MH1X_2aef634b-99ce-4329-8	2
0.42	C01	D	Deformed sewer, 20% of original diameter/height, change: at 10 O'clock	00:00:08	MH1X_31cd0bca-9743-4b55-bd	
0.61	C01	D	Deformed sewer, 20% of original diameter/height, change: From 8 to 12 O'clock	00:00:09	MH1X_0ead1eea-6abd-4097-b	
0.76		SA	Survey abandoned: Unable to push camera past	00:00:11	MH1X_a2c45cb7-d2ab-4a43-b4

Construction Features					Miscellaneous Features				
Structural Defects					Service & Operational Observations				
STR No. Def	STR Peak	STR Mean	STR Total	STR Grade	SER No. Def	SER Peak	SER Mean	SER Total	SER Grade
1	0.0	26.3	20.0	2.0	0	0.0	0.0	0.0	1.0

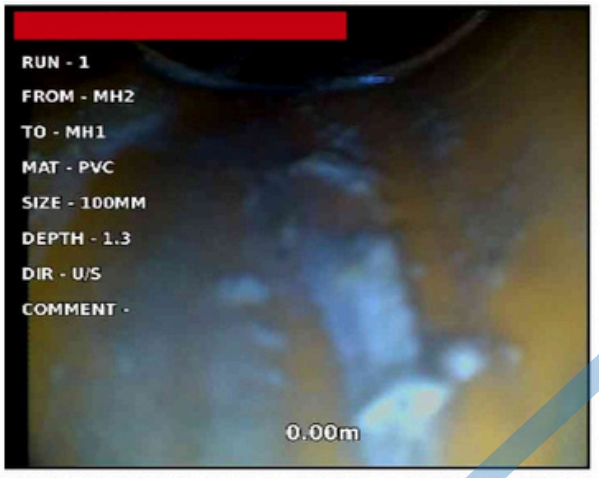
MH1X_b53e8da0-8edf-416d-adb7-521aec5a8525_20250120_133913_873.jpg, 00:00:00, 0.00 m
Start of survey

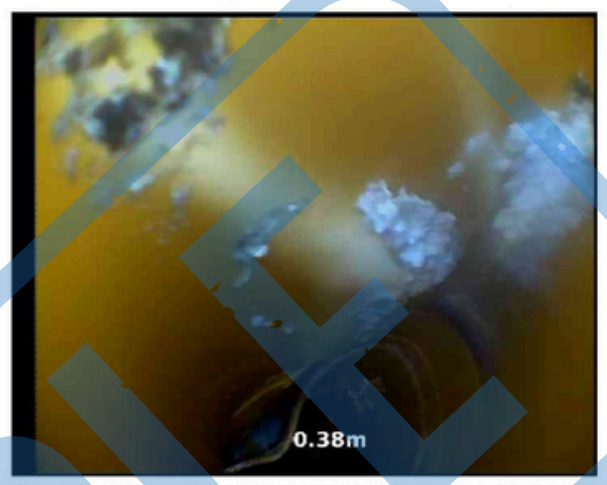
MH1X_2aef634b-99ce-4329-8ae6-b0b68861c6e4_20250120_134027_186.jpg, 00:00:08, 0.38 m
Deformed sewer, 10% of original diameter/height, start, at 10 O'clock

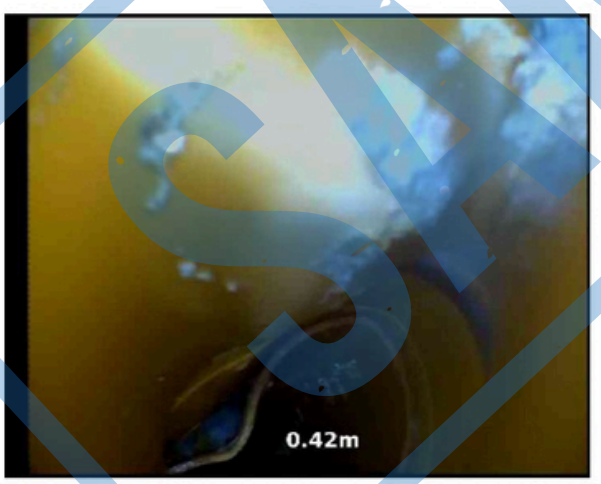
MH1X_31cd0bca-9743-4b55-bd9b-c455b6255c9d_20250120_134102_101.jpg, 00:00:08, 0.42 m
Deformed sewer, 20% of original diameter/height, change, at 10 O'clock

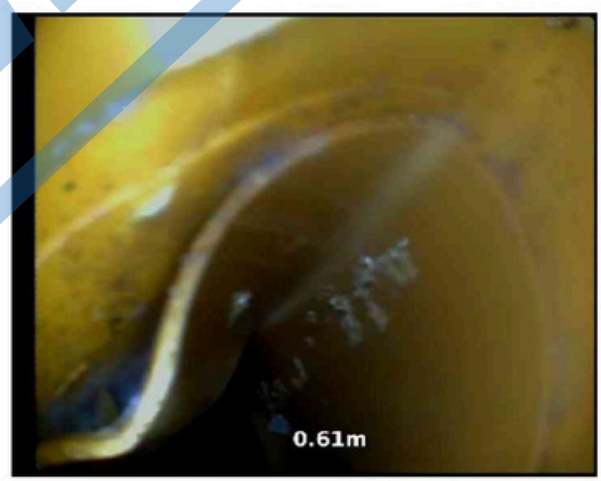
MH1X_0ead1eea-6abd-4097-b27f-b7b020615ea3_20250120_134214_214.jpg, 00:00:09, 0.61 m
Deformed sewer, 20% of original diameter/height, change, From 8 to 12 O'clock

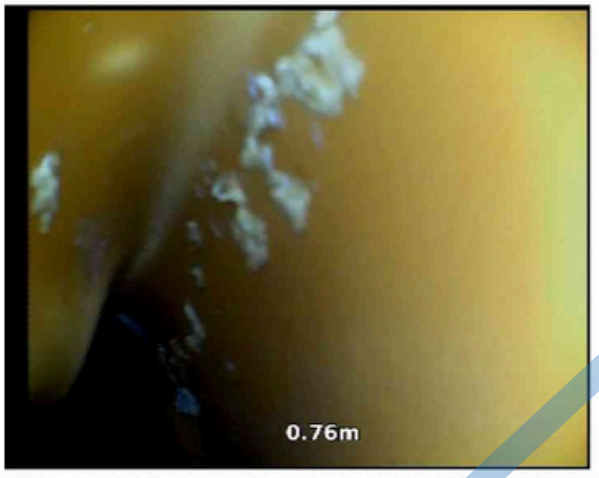
MH1X_a2c45cb7-d2ab-4a43-b42d-48ccef41a087_20250120_134255_553.jpg, 00:00:11, 0.76 m
Survey abandoned, Unable to push camera past
